# Common Fire Sprinkler Deficiencies Found in New Building Construction

By John H. Jackson, Fire Safety Project Manager

This month's Lessons Learn Bulletin focuses on common fire sprinkler deficiencies found in new building construction.

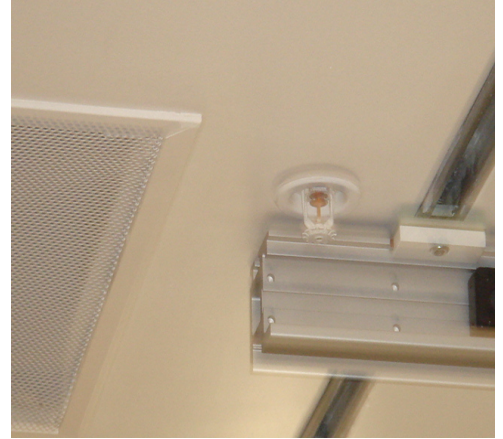
The first deficiency has to do with improper coverage under fixed obstructions. NFPA 13, Chapter 8, requires sprinkler protection under fixed obstructions over 4 feet wide, such as duct work and open grate flooring. Environmental Health and Safety continues to find unprotected duct work on new construction projects at the time of building commissioning. In several cases, this is due to additions being made to the original duct design or ducts being insulated.
