# Unapproved Utilities and Membrane Penetrations in Exit Enclosures

By John H. Jackson, Fire Safety Project Manager

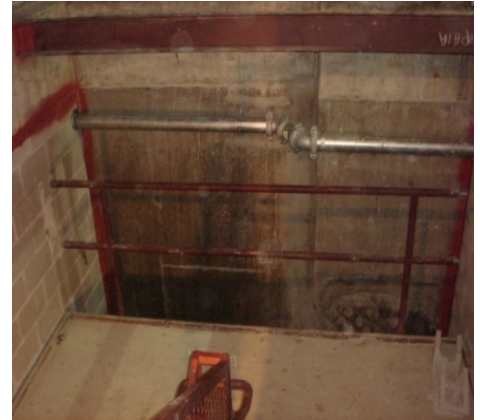
Over the years, Environmental Health and Safety continues to see an increasing number of through-penetrations in exit enclosures and exit passageways for the routing of unapproved utilities. Some examples include roof drains that don't support the stair roof, medical gas lines, HVAC ductwork, natural gas piping, high voltage power, acid waste drain lines and elevator sump pump drains lines like shown in the picture of this bulletin.

It is recommended that anyone involved in the design or installation of equipment that might affect the exit enclosure, first review the requirements in both the in NFPA 101 Life Safety Code **Chapter 7, Section 7.1.3.2.1 (9)** and the Underwriters Laboratories, Fire Resistance Directory, to ensure your design or installation is code compliant. By understanding and following this recommendation it will help ensure your design and installation complies with the NFPA 101 Life Safety Code and the Underwriters Laboratories, Fire Resistance Directory.
